PERFORMANCE EVALUATION OF EXISTING BUILDINGS IN THE AUGUST 24, 2016 CENTRAL ITALY EARTHQUAKE

MARIA HELENA PAIXÃO COSTA

Dissertação submetida para satisfação parcial dos requisitos do grau de
MESTRE EM ENGENHARIA CIVIL — ESPECIALIZAÇÃO EM ESTRUTURAS

JUNHO DE 2017

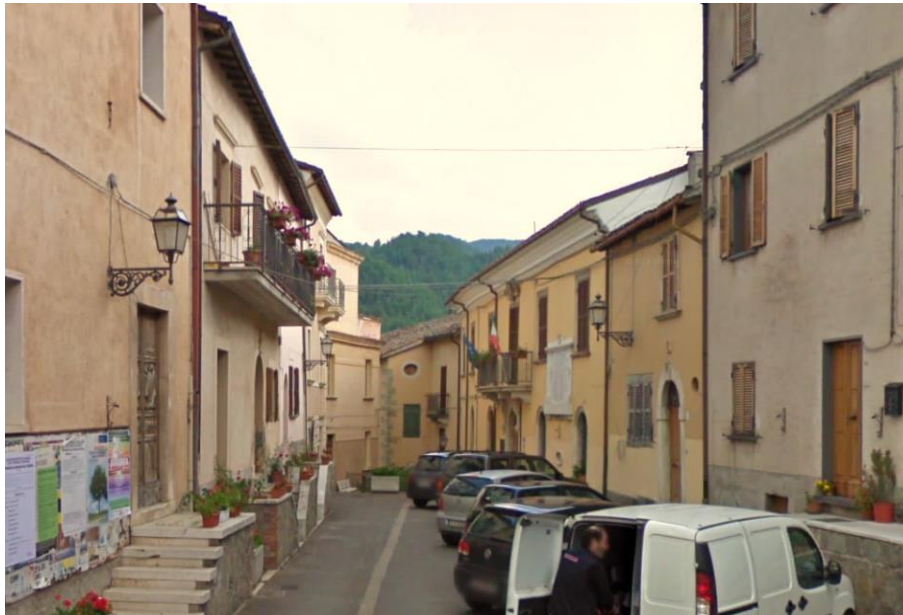
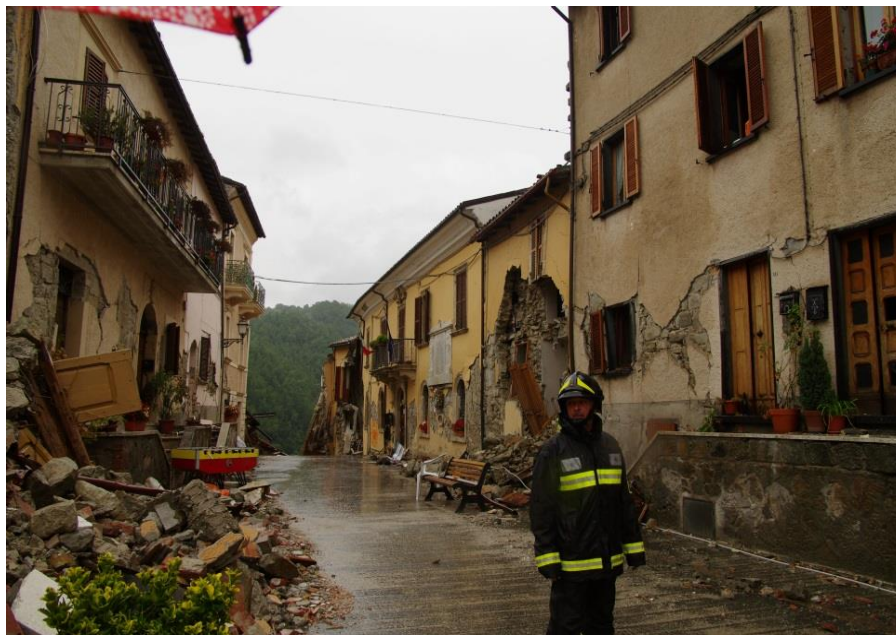
Global collapse of the two buildings in the end of the street. Diagonal shear cracks in pier panels (type 3) and overturning of the external leaf of the yellow building, detailed in section 5.1.1.1.

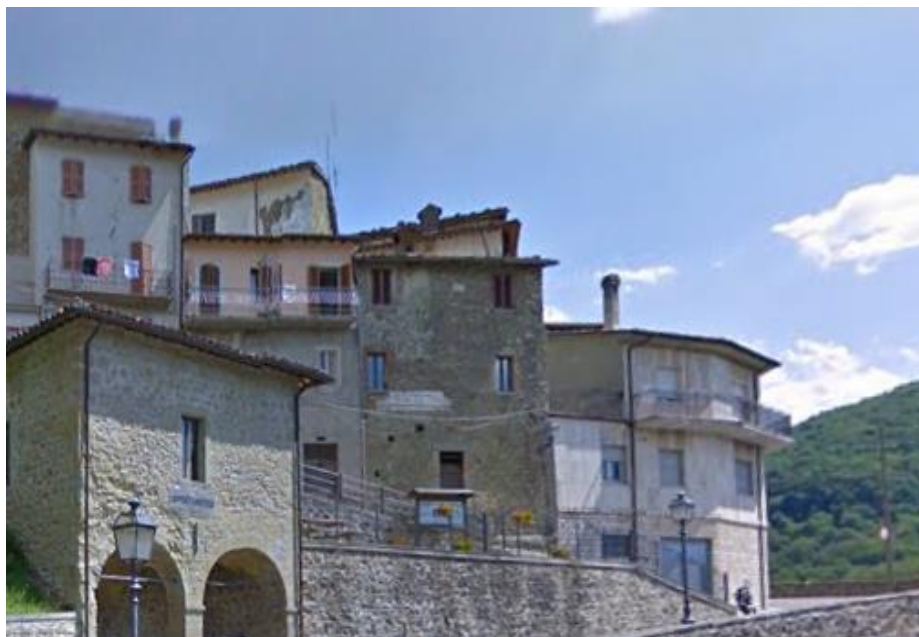
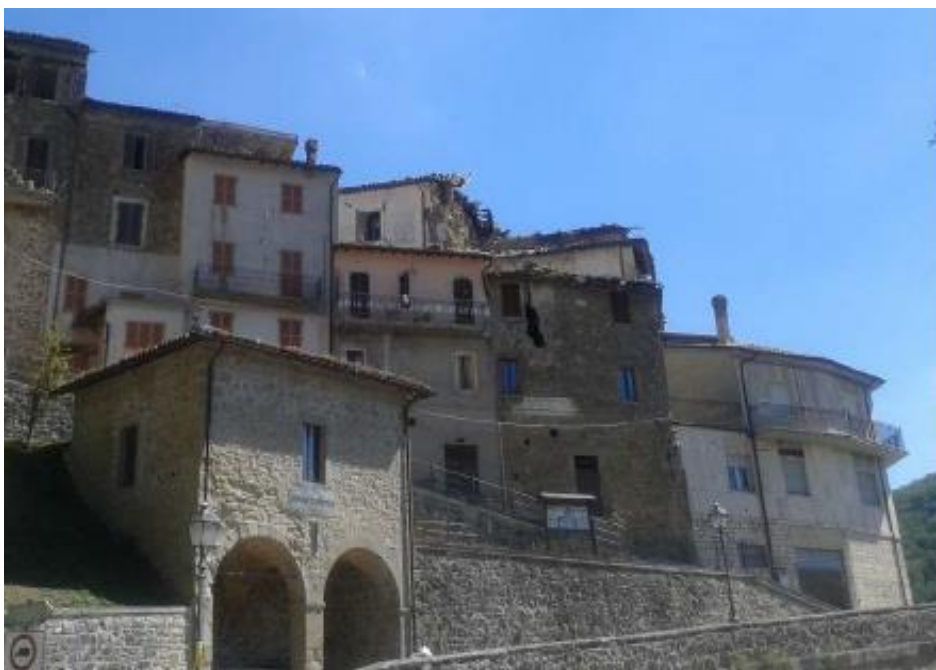
Most of the buildings in this area survived the earthquake. From the image it is possible to observe severe damage in two buildings.

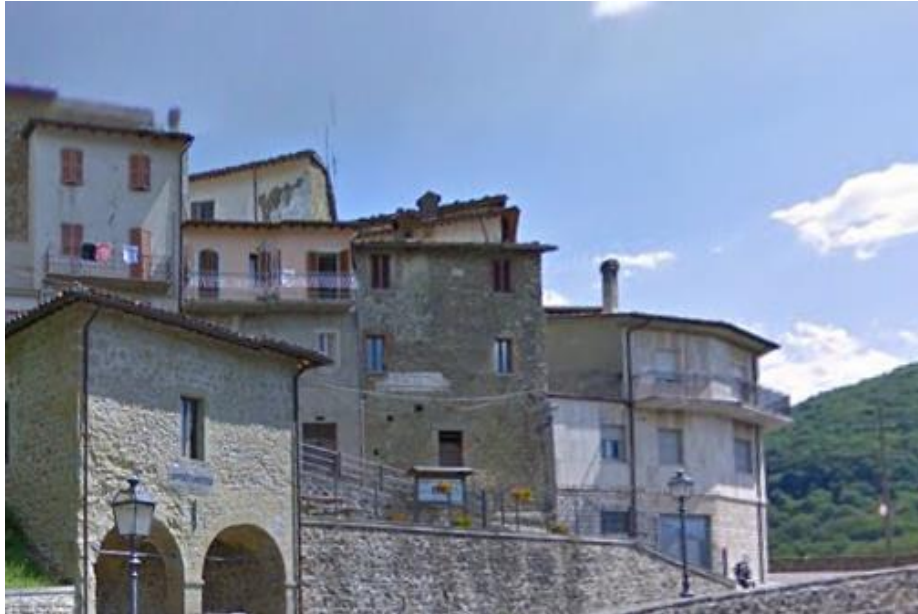
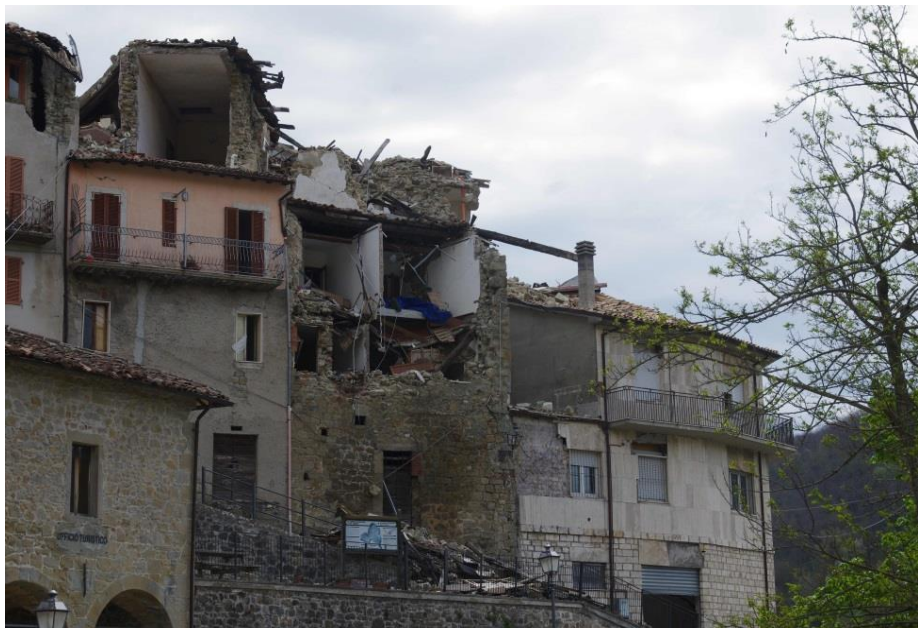
Severe damage to the masonry buildings, including partial collapses. Most of the buildings that resisted the August event perished in the following month, as it was expected.

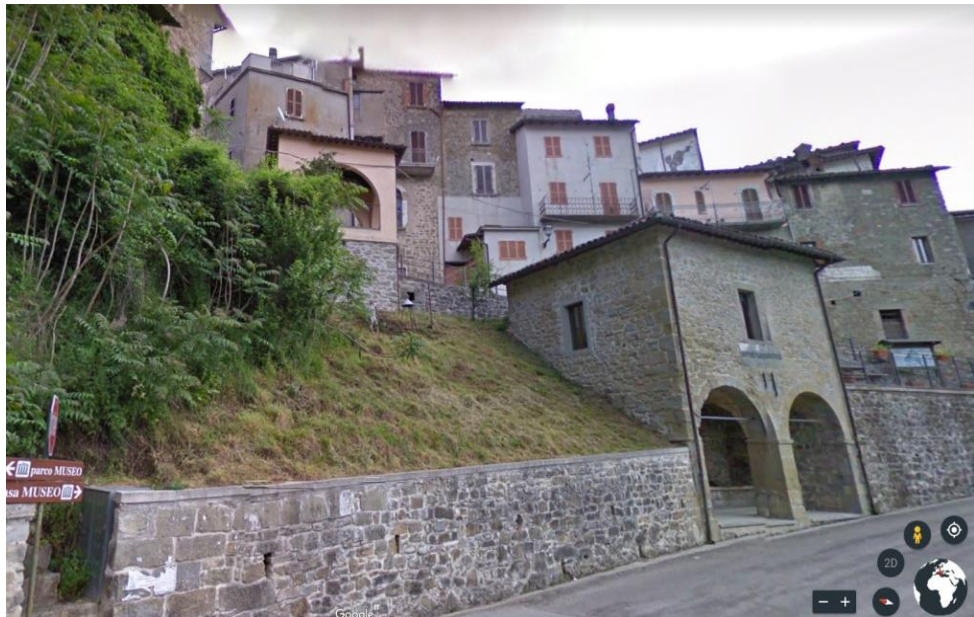
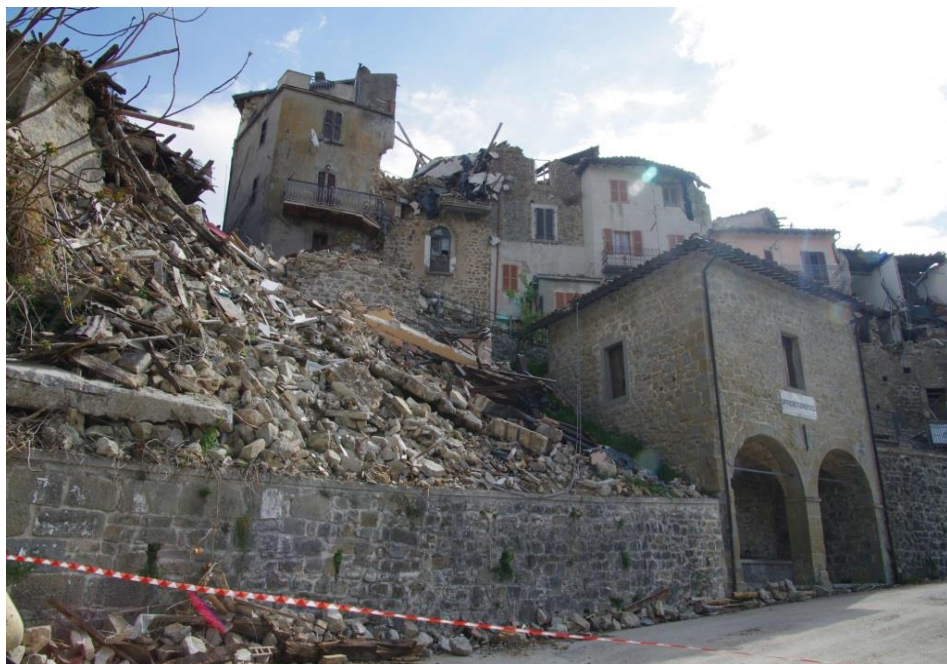
Full/ partial collapse of masonry buildings.

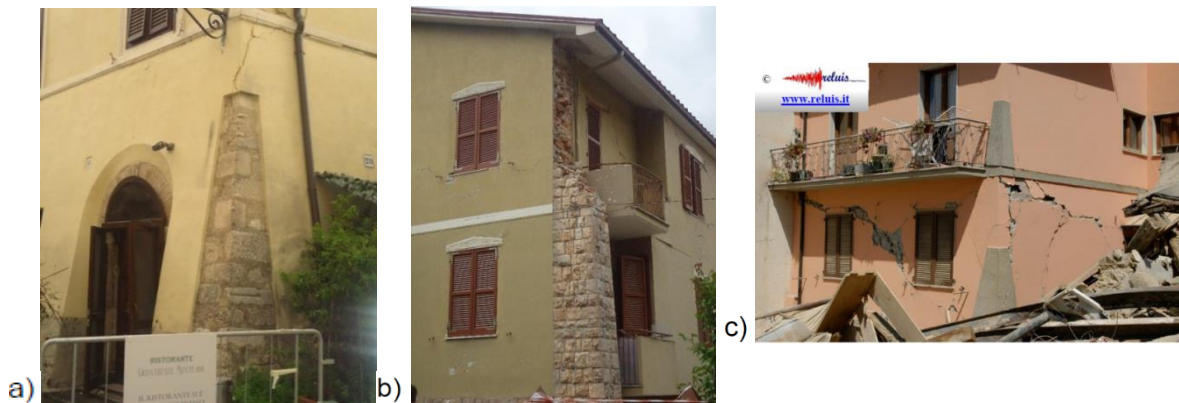
Figure 6.3-Buttress a) and b) in Norcia and c) in Amatrice In a) the reinforcement prevented the spreading of cracks. c) severe in plane and out of plane damages

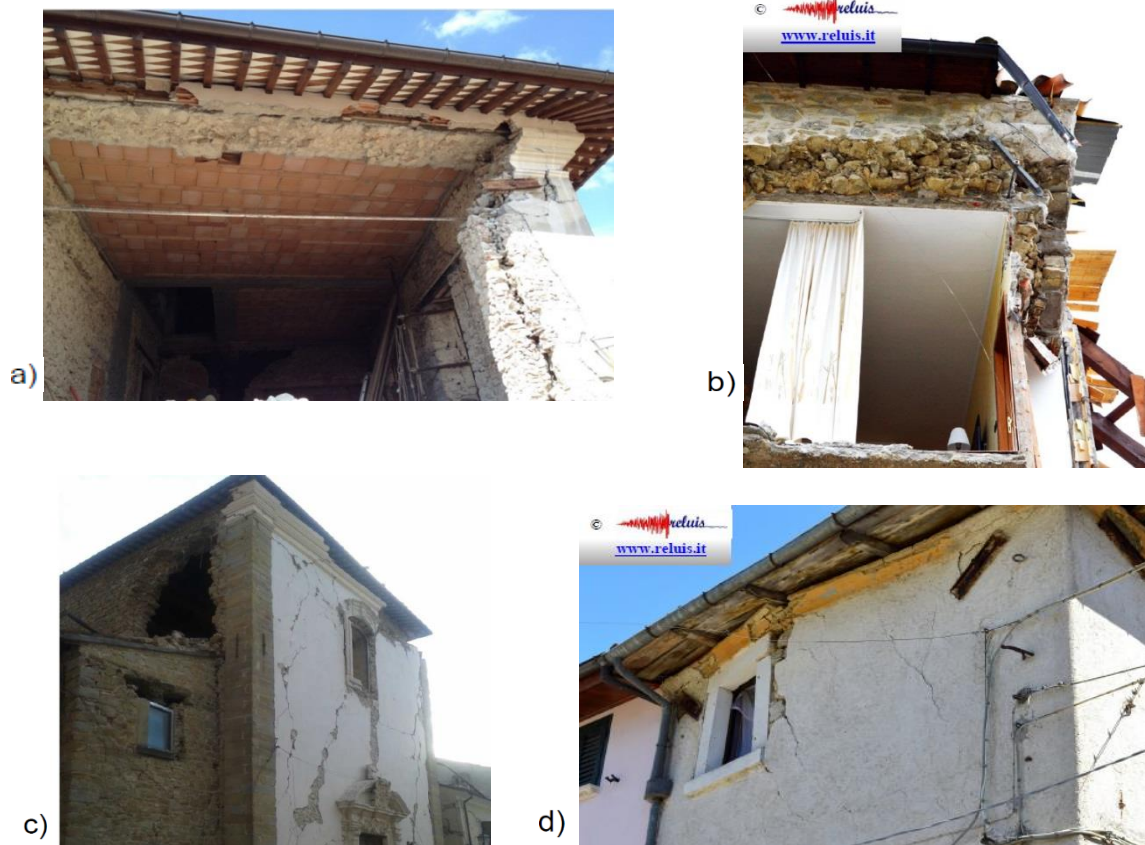
Figure 6.8-Failure of masonry buildings with tie rods. a), c) and d) Amatrice and b) Arquata del Tronto
